# Diagnosing Deficiencies in Post Tensioned Bridges

OTEC CONFERENCE 2018

# Summary of Conditions and Testing of 3 Span PTS Bridge

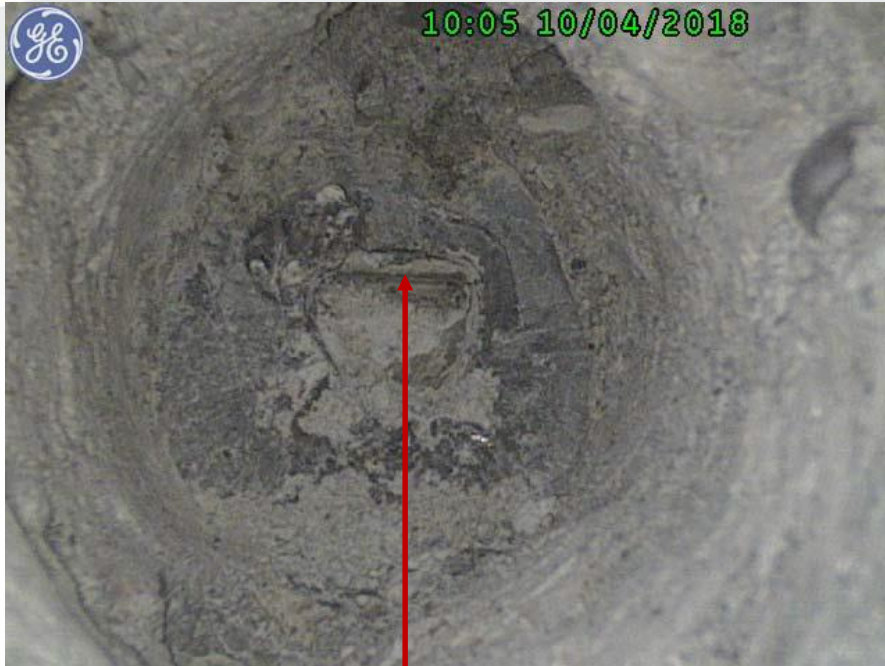
Looking into borescope test location at duct full of grout.

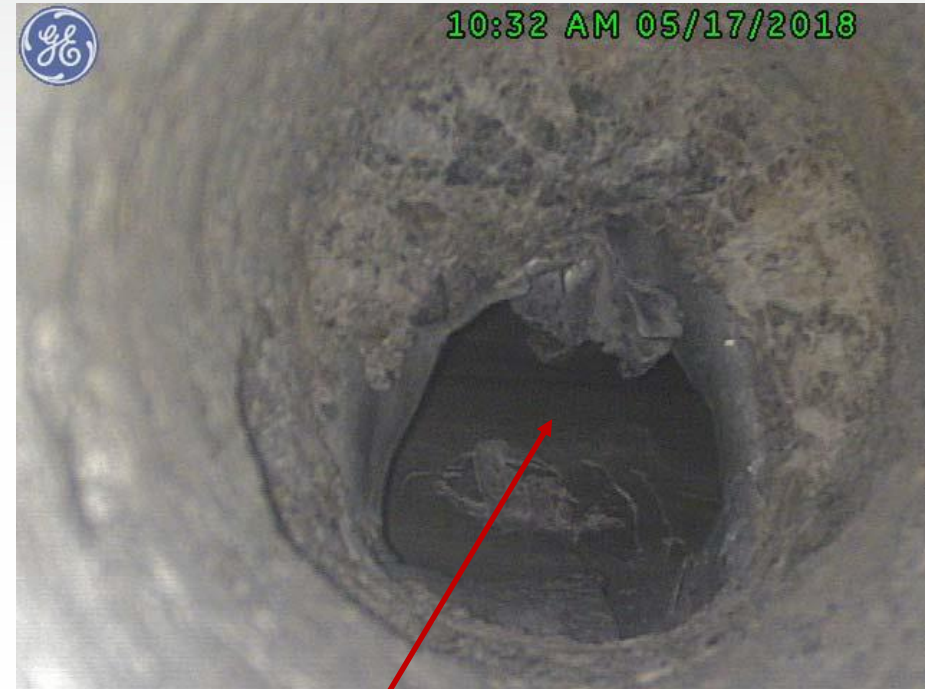
Looking into borescope test location, void at top of duct

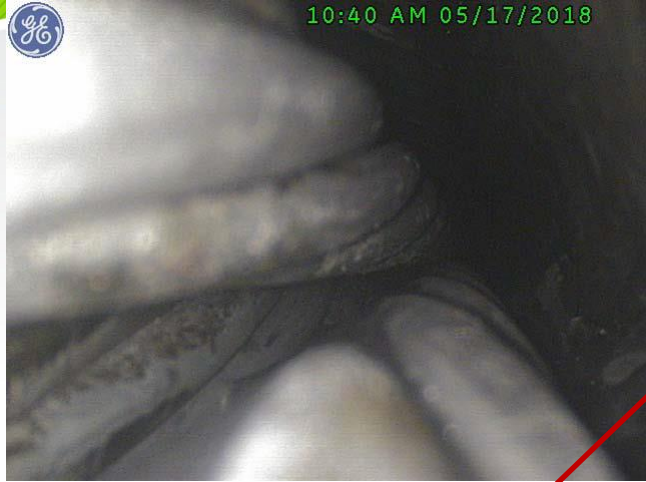
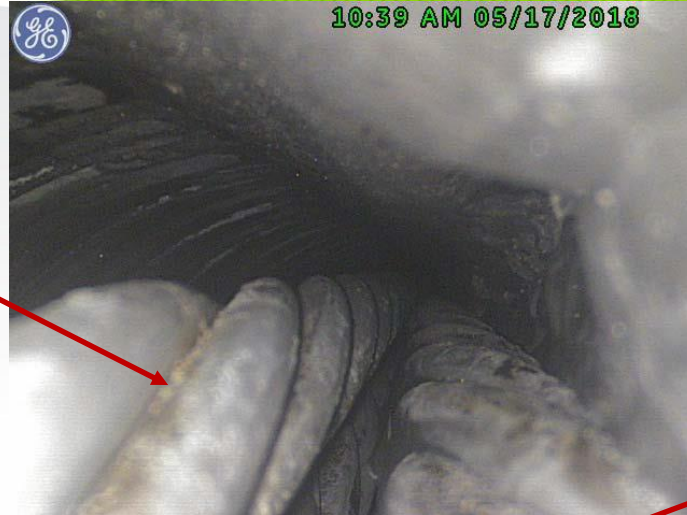
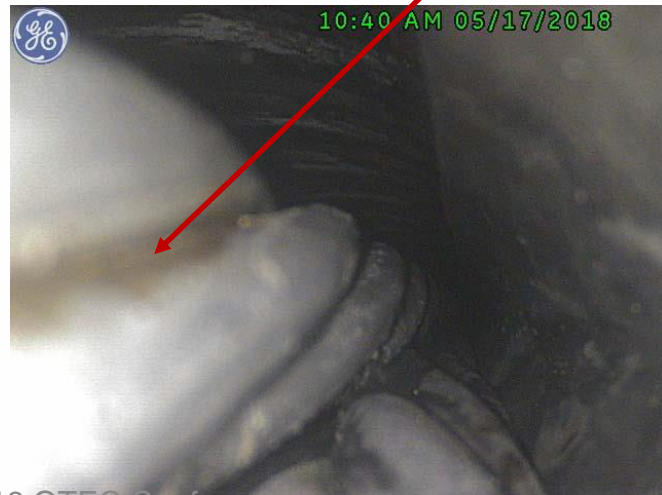
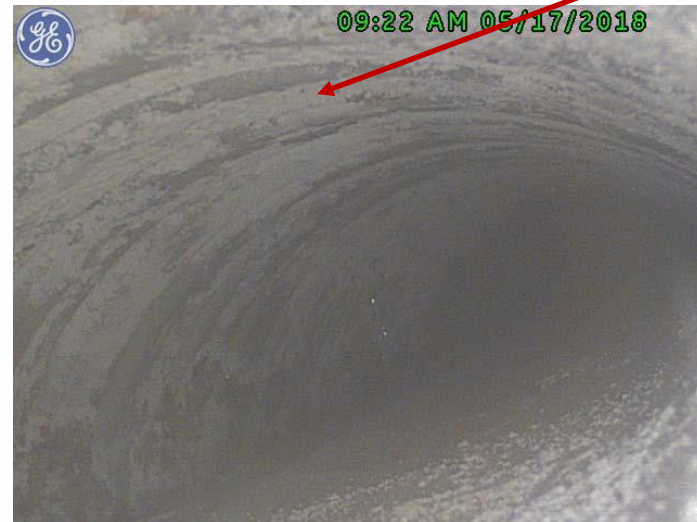
# PTS Interiors of Duct Voids-3 Span

- Initial cracks/lower strength concrete
- Chloride content 0.013%, sulfate content less than 3%.
- Grout high pH, moisture below 25%, low grout corrosion rates.
- 20 of 36 (56%) locations had voids. Void depths ranged from 0.25" to 2.0".
- Voids; Strands above grout/light corrosion steel strands-duct interiors/moisture entering voids.
- Highpoint voids are only a few inches below the top of deck
- Advantageous conditions of bridge
  - Structure is 18 years old/ corrosion has just initiated.
  - Existing grout is of good quality, should protect the embedded steel strands.

- Concrete bridges crack with age/to prevent corrosion of the PTS we recommend:
  - Most water comes from the deck, interval application of flood coat will help.
  - Remedial grouting of voids per current ASBI and PTI specifications.
  - No further borescope testing required if remedial grouting is performed.
  - Perform corrosion rate analysis and grout analysis every 10 years to check for carbonation reaction.
  - Web shear cracks should be monitored for growth.
  - Perform baseline survey to check for future sags and deflections of the box girders.

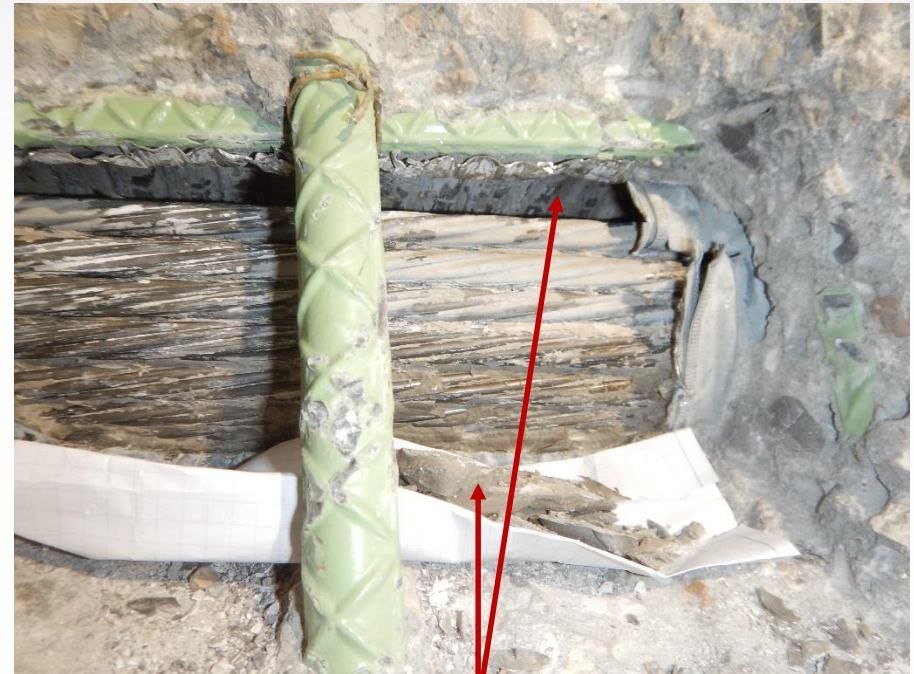
Typical grout sampling from the exposed tendon duct. Note void at top of duct

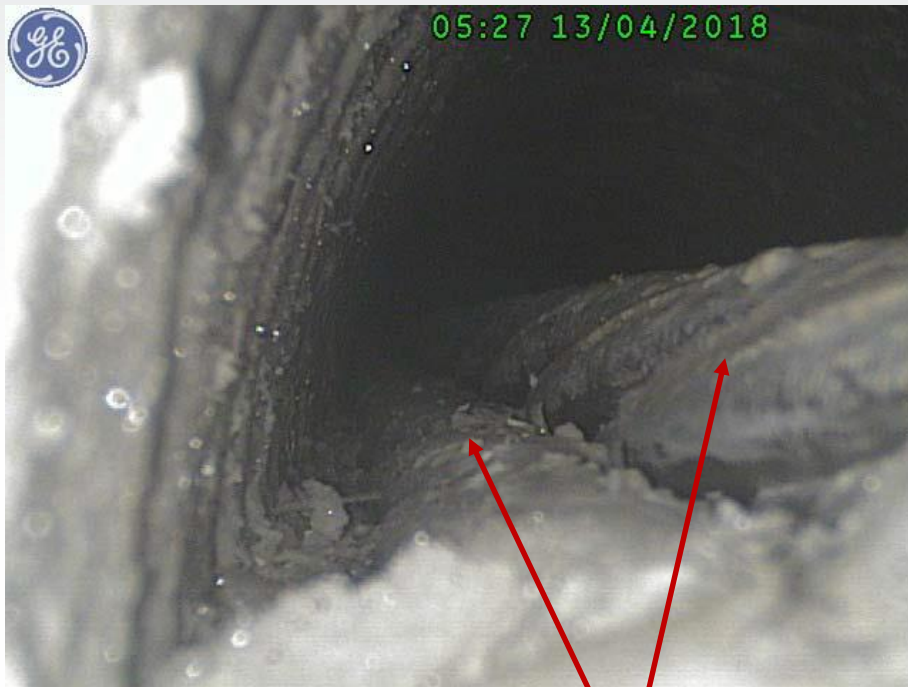
Void at highpoint with exposed tendon strands

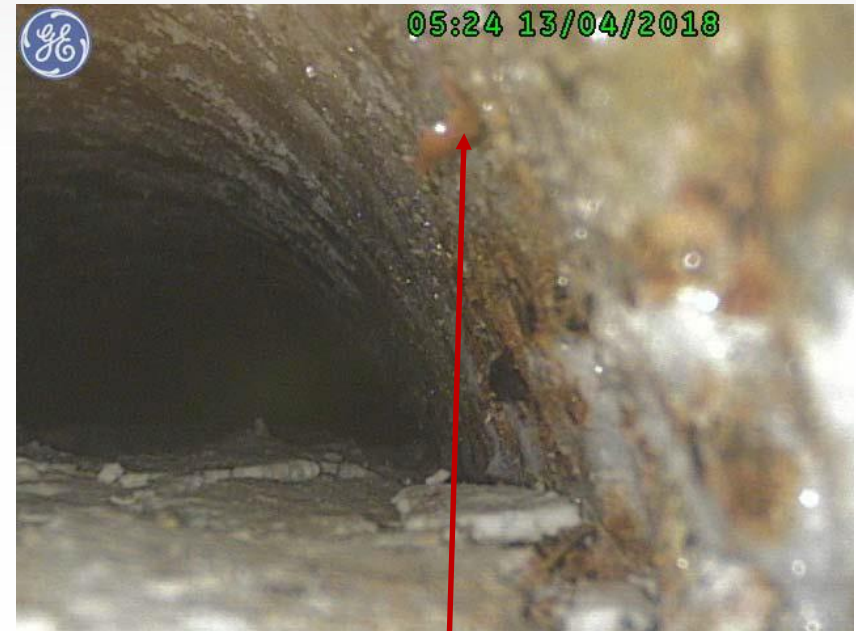
Void at highpoint with moisture corroding the duct interior

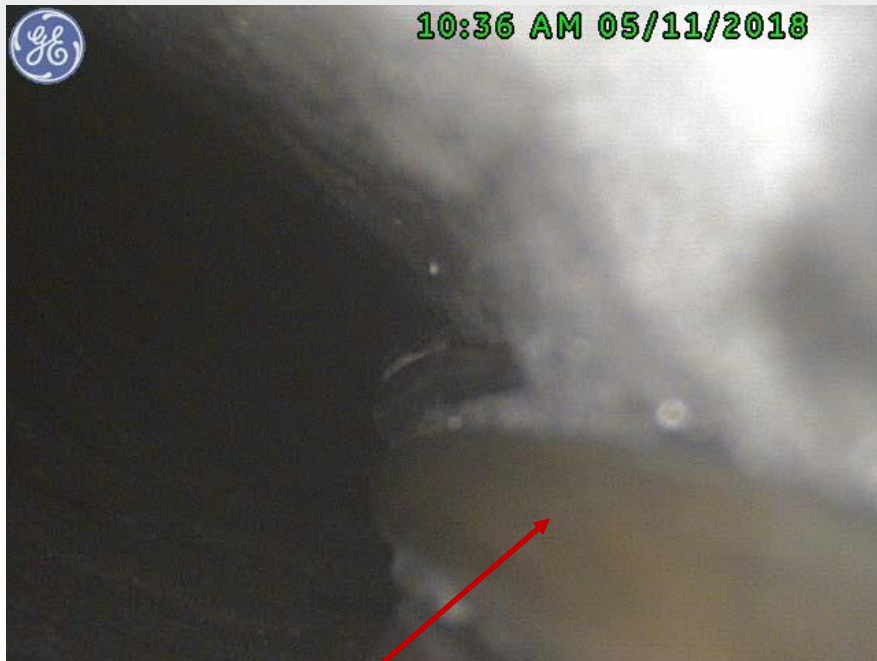
Light corrosion of strand wire at void, indicates moisture in void

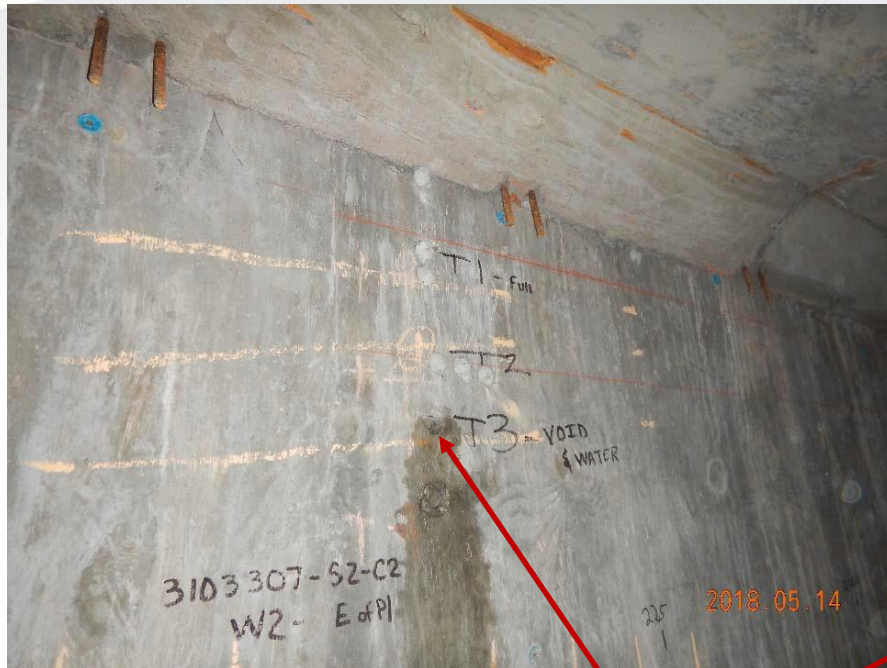
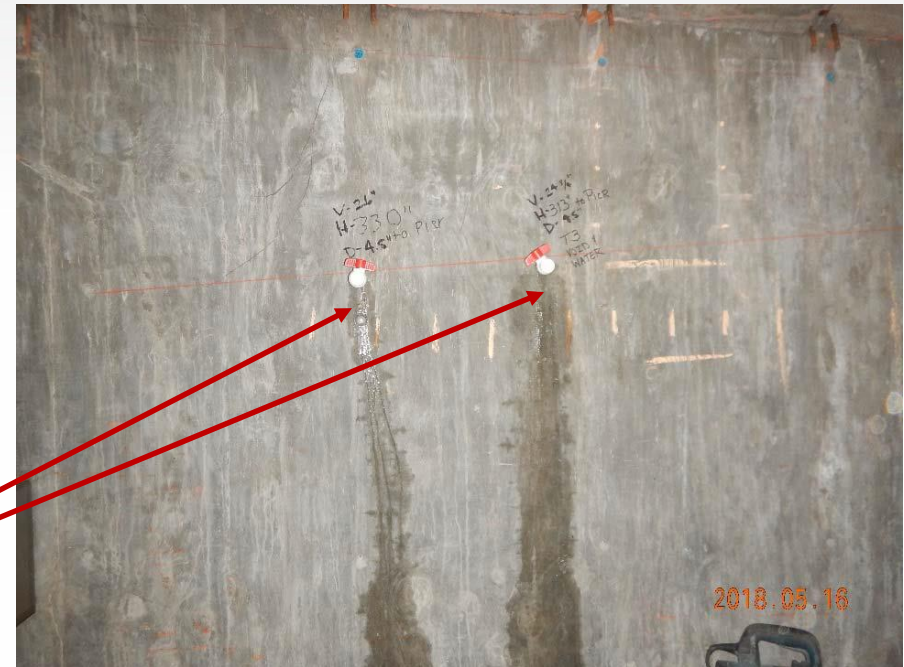
Water draining from 3 separate locations along Tendon 3

- Five span bridge summary is similar to the 3 span bridge except for the following:
  - 16/78 (20%) locations had voids. Void depths ranged from 0.125 inches to 4.0 inches.
  - One void had 5 gallons of water. Concrete cracks/additional moisture?

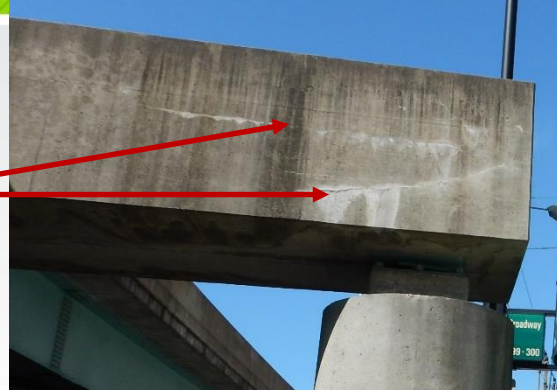
East side, north half,  
note cracks up to  
0.036 inches wide

West side, north half,  
note cracks

- Pier Caps 2,3 and 4/replace concrete block outs with non-shrink and urethane clearcoat.
- The heads of the anchor assemblies should be cleaned of all corrosion
- All voids in the anchor trumpets and grout vents should be filled with an approved pre-packaged grout
- All anchor head assemblies should have an approved plastic cap installed over them and vacuum grouted with an approved pre-packaged grout
- ASBI and PTI guidelines should be the controlling specifications for all PTS rehabilitation
- The cracks at the north end of PTS Pier Cap 2 should be cleaned and epoxy injected to protect the PTS

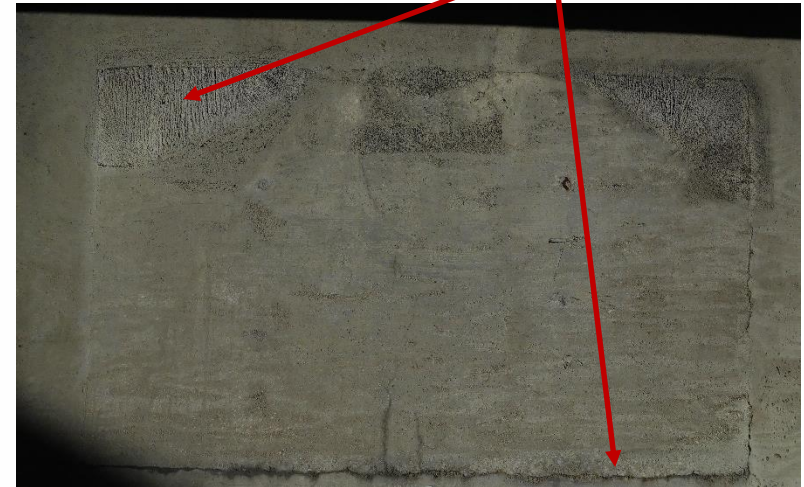
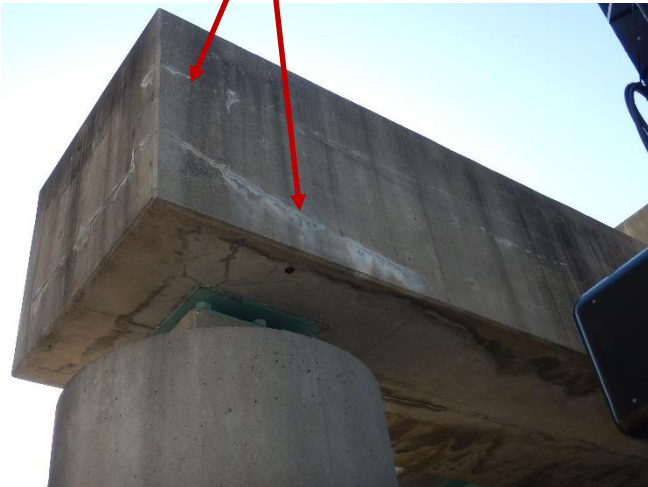
Blockout at south  
end of PTS Pier  
Cap 2. Note  
rough patch and  
shrinkage cracks

- Regular concrete was used in block outs creating shrinkage cracks/water enters the anchor assemblies
- 2 of 4 anchor assemblies exhibited moderate to heavy corrosion.
- 2 of 4 grout vents were empty/vents exhibited heavy corrosion/voids in the trumpet areas.
- Moisture may be accessing into the anchor trumpet and tendon strands.
- 4 of 16 locations were tested/failure rate of 50%. 8 locations potentially at risk of corrosion.
- Pier Cap 3 and Pier Cap 4 of HAM-50-2142R/may have corrosive conditions.
- Cracks at the north end of P2 have not grown since being created around construction.
- Grout quality was good/similar to 3 span and 5 span bridges

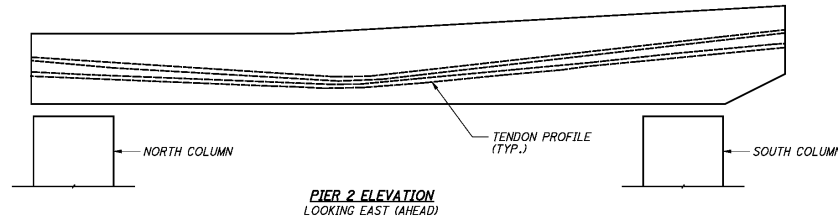
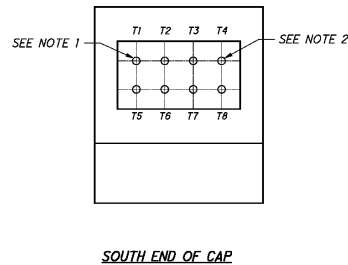
Pier Cap 2 Detail Drawing

1. 1/4" VOID WITH EXPOSED AND MODERATLY CORRODED STRAND WEDGES AND TAILS. TOP 1/3 OF ANCHOR HEAD HAS SOFT GROUT. GROUT VENT PIPE IS EMPTY.
2. 1/4" VOID THROUGH GROUT PORT. UNABLE TO REACH TENDON DUCT. ANCHOR PLATE EXHIBITS MOISTURE AND CORROSION.

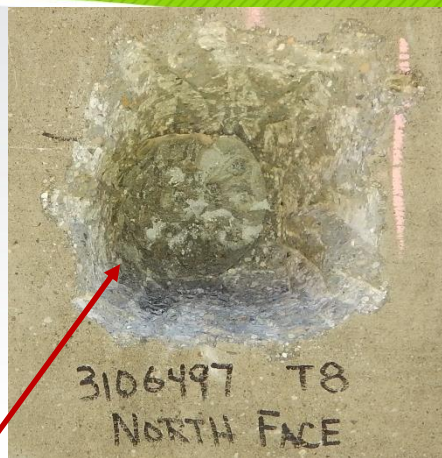
Completely exposed Tendon 8 exterior anchor assembly

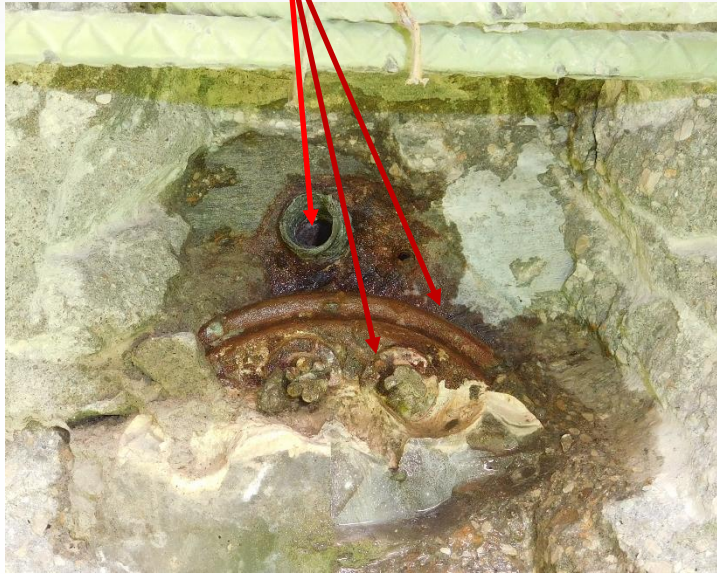
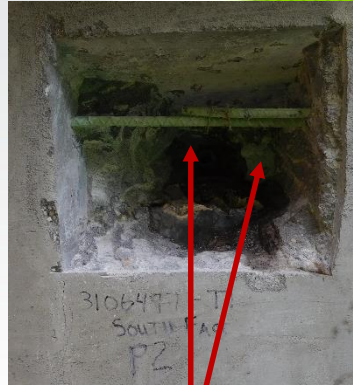
Exposed anchor assembly, empty grout vent and moisture

Chipping operation to the anchor assembly, note moisture

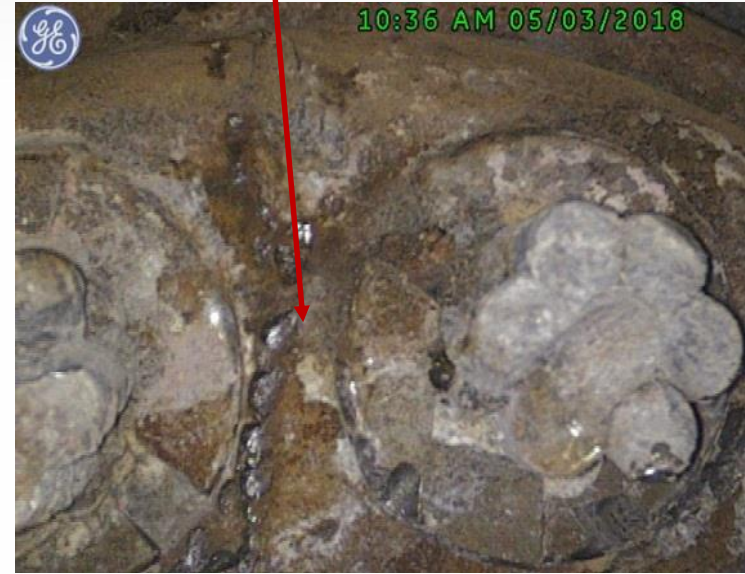
Exposed anchor assembly, note corrosion

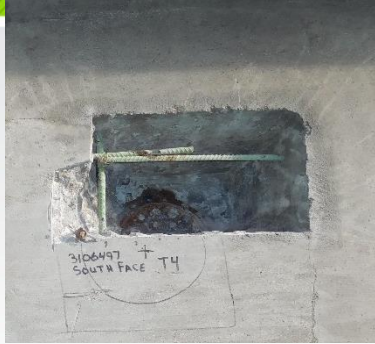
Note moisture at interior of blockout

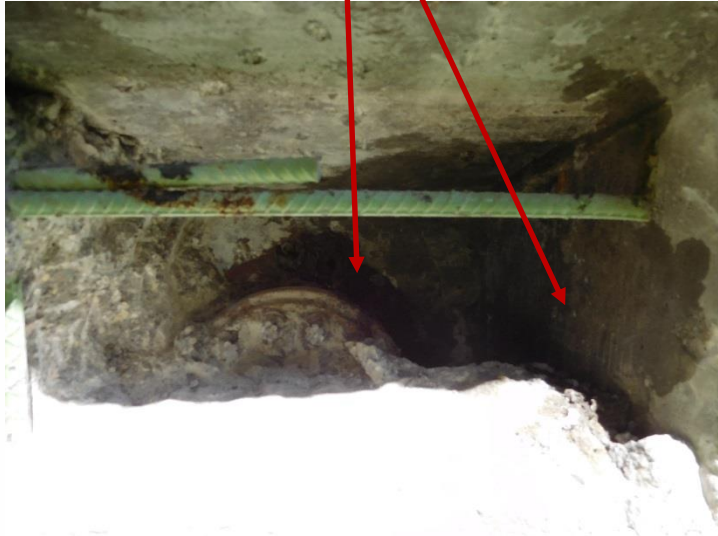
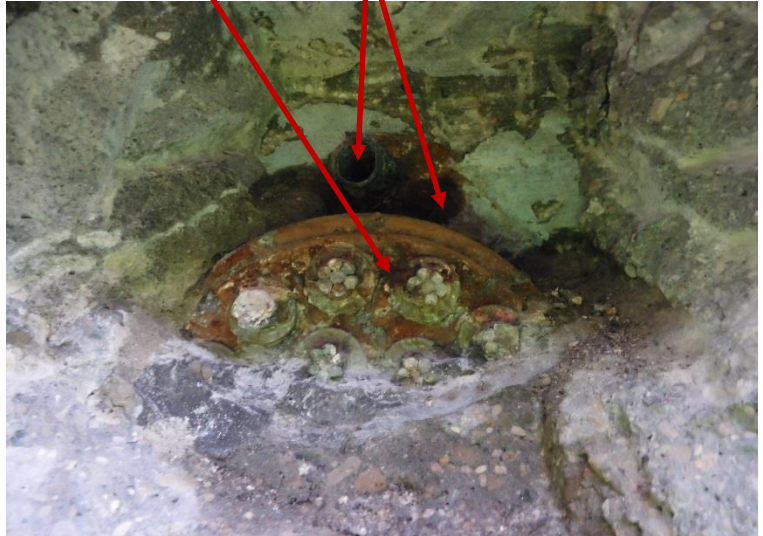
Note corrosion of anchor assembly, empty grout tube and moisture

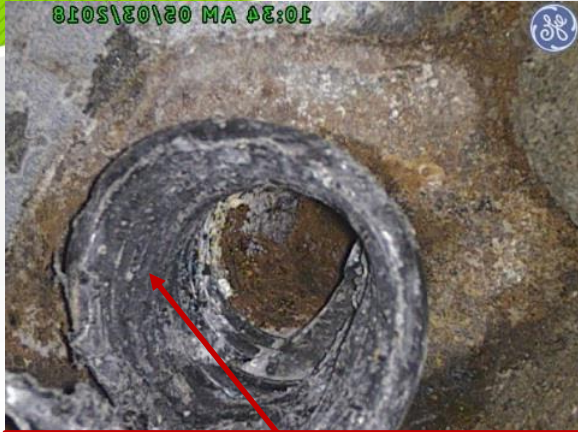
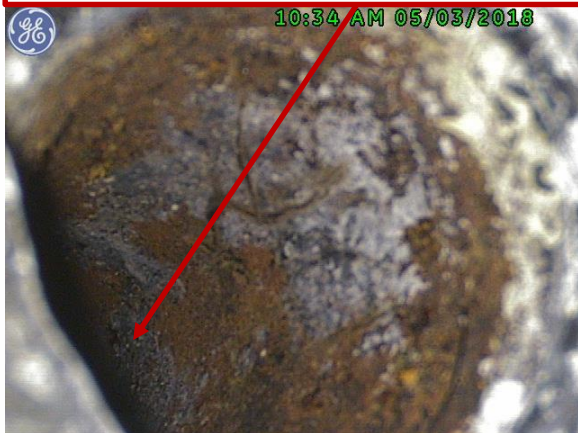
Entrance to empty grout vent and corrosion at vent interior

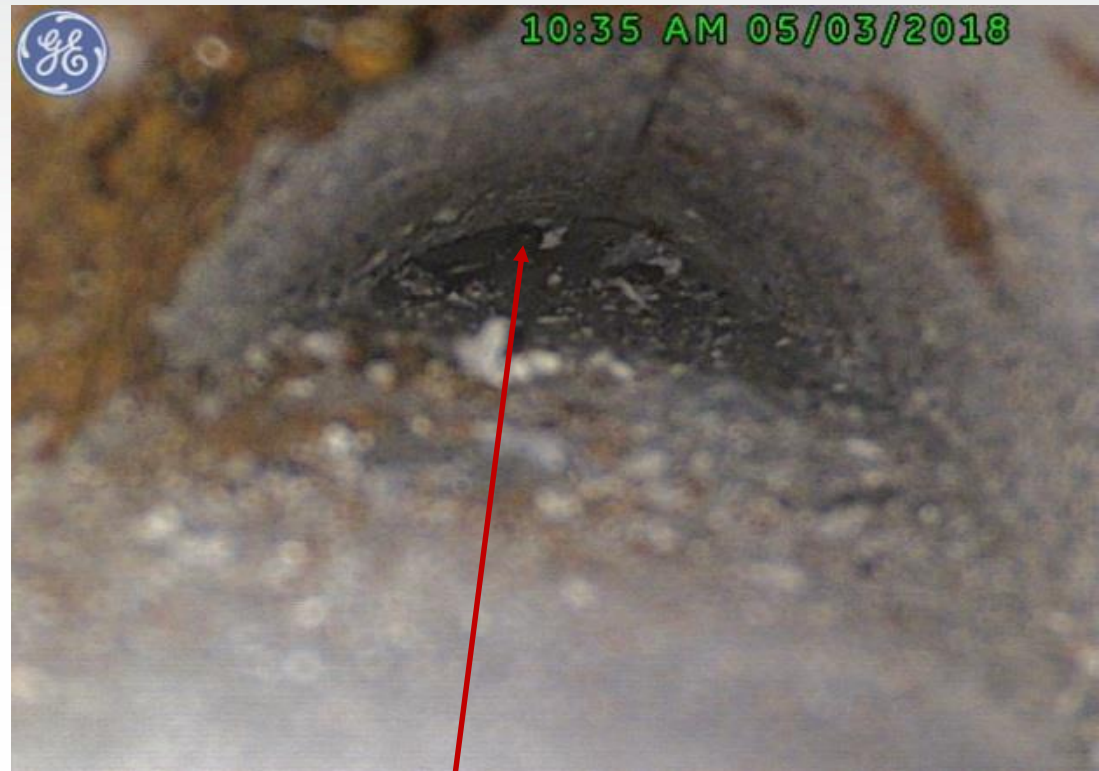
1/4 inch void between trumpet and grout vent

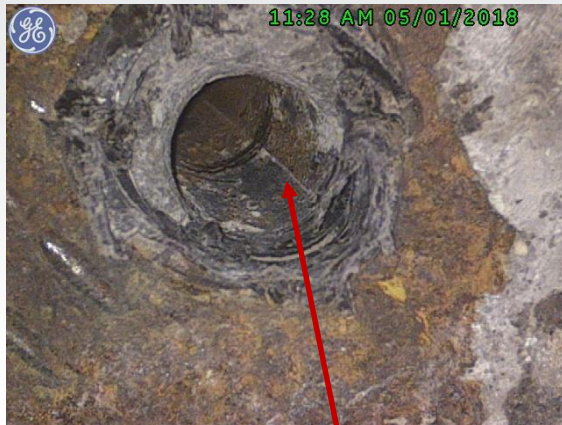
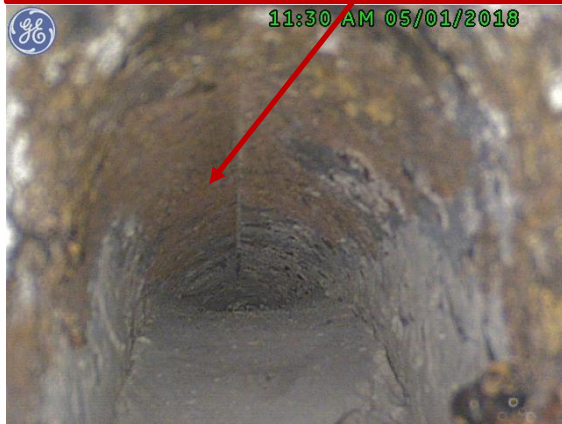
Entrance to empty grout vent and corrosion at vent interior

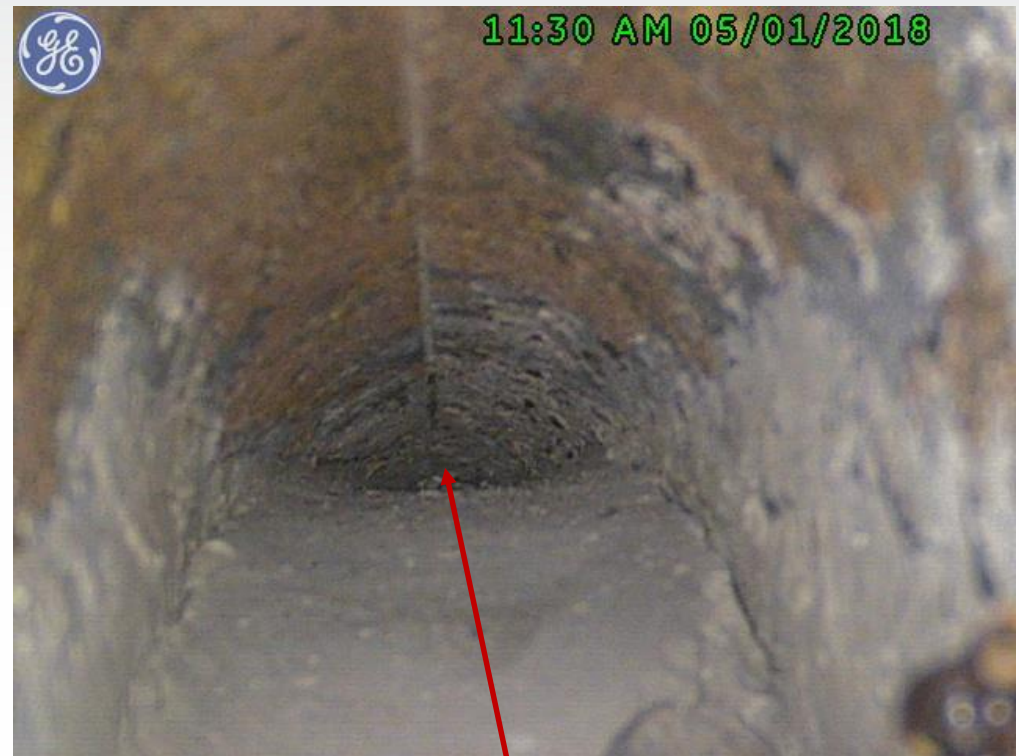
1/8 inch void between trumpet and grout vent
