Rehabilitating and beautifying an aging bridge

Engineering evaluation identified the most critical repairs to save the 107-year-old Market Street Bridge.

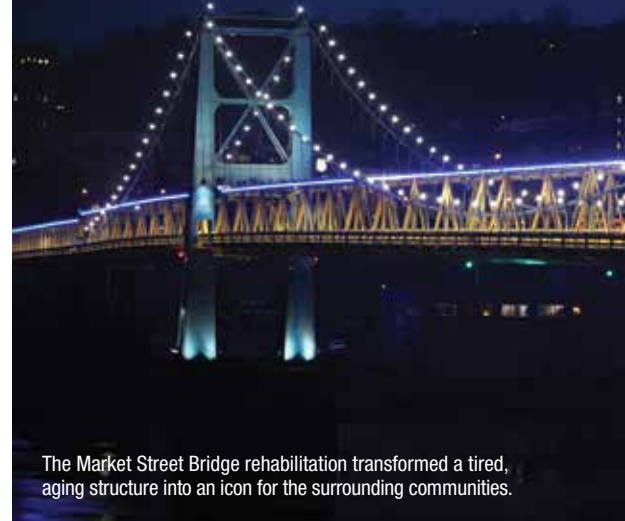
The Market Street Bridge rehabilitation transformed a tired, aging structure into an icon for the surrounding communities.

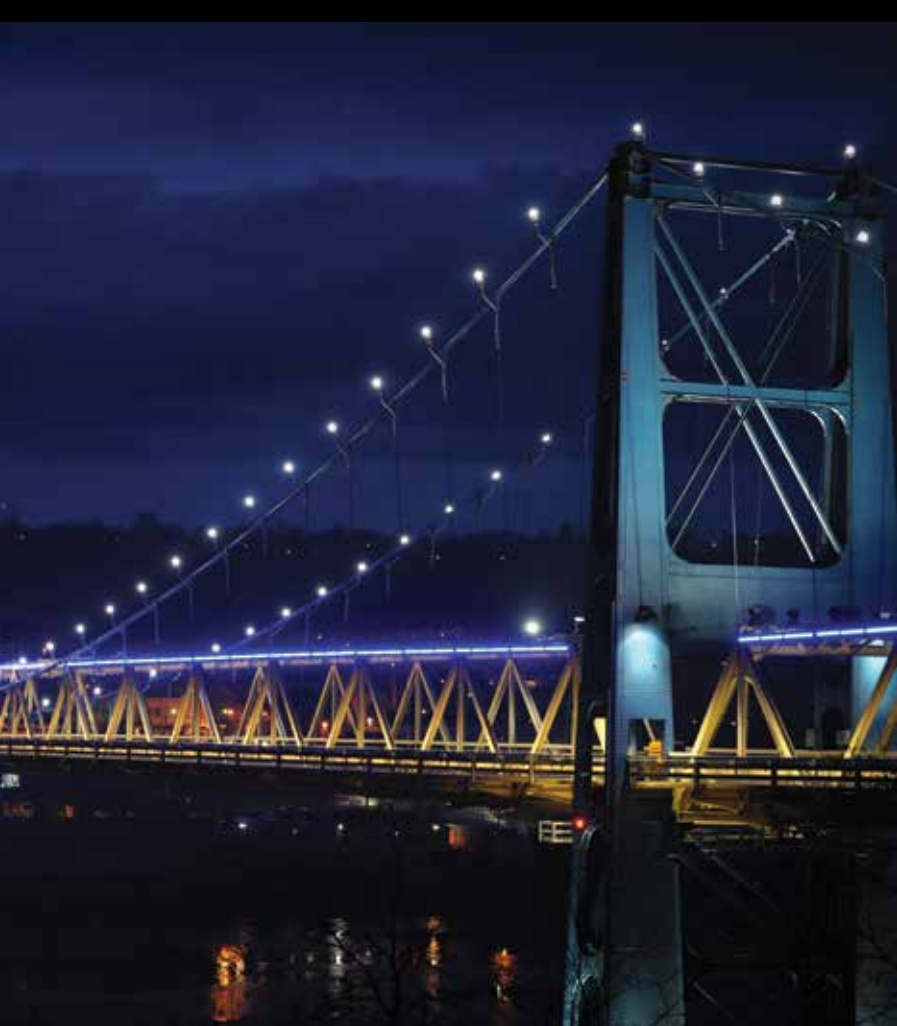
Above: Specially trained Burgess & Niple engineers used rope access to inspect the towers, cables, and trusses without closing the bridge to traffic. Right: The 1,704-foot-long Market Street Bridge, shown here before rehabilitation, was constructed in 1904 and had undergone several modifications during its life but had not had many repairs since the 1980s.

Other repair work included strengthening the stiffening trusses, steel strengthening work to the main tower legs, reattaching the plates that were added in the 1940s — but with continuous welding instead of intermittent. There was lots of welding and adding plates and replacing some of the rocker post bearings. We were able to replace the rocker post bearings with more modern and maintenance-free materials.

Whited: We replaced floor beams and stringers. The deck had to be removed to replace the stringers. The approach trusses had to be strengthened to maintain their capacity. Additional uplift anchorage was added at the abutment. The area around the eyebars was concreted. Previously, they were unpainted steel going underground, so we added concrete for protection.

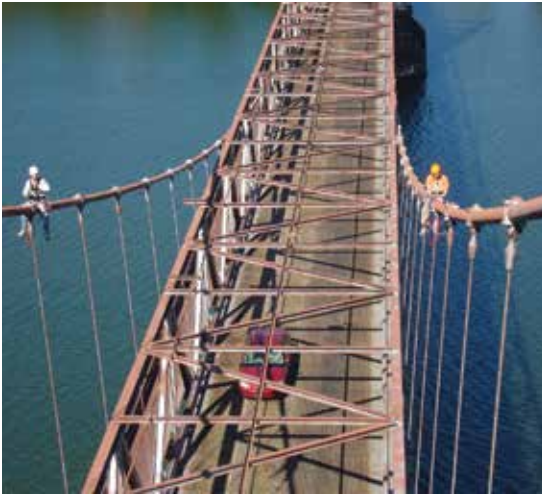
Lewellyn: Industrial rope access was used to access the towers, cables, and trusses without closing the [bridge to] traffic. About 30 of us at Burgess & Niple are trained for rope access. When we started inspecting this bridge in 1991, we were the pioneer in using climbing to access bridges. Now, there are still only a handful of companies that are capable of completing an inspection like this. It saves the cost of renting a man lift and flagging traffic. Providing a hands-on inspection while keeping bridge users safe and on-time is our goal. It is low-impact.

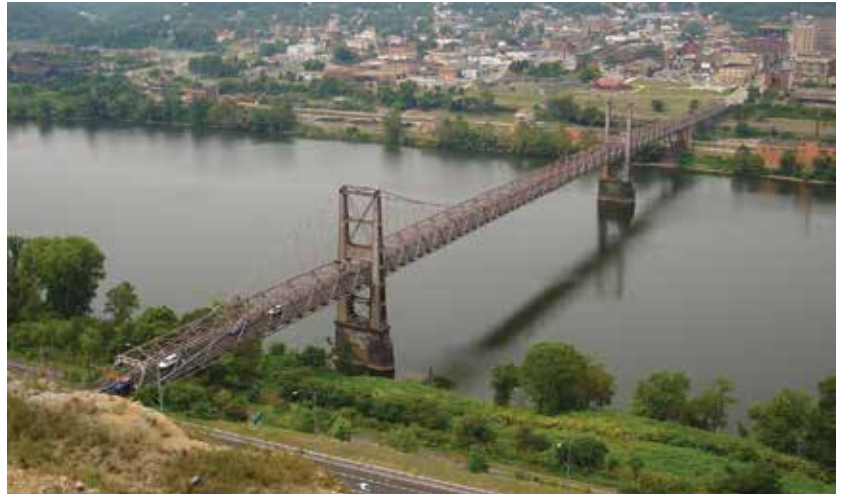
Lewellyn: The bridge hadn't had many repairs since the 1980s. With the open grid, the roadway salt accelerates deterioration. The necessary repairs were determined through inspection. We had seen the deterioration through the years. The ability to repair the bridge now was due to the available ARRA funds. When the nearby Fort Steuben Bridge was demolished, that put more traffic on the Market Street Bridge, and the public supported the rehabilitation.
