TECHNICAL PAPER

Post-Tensioned Bridges: Diagnosing & Remediating Corrosive Conditions

BURGESS & NIPLE
Engineers ■ Architects ■ Planners

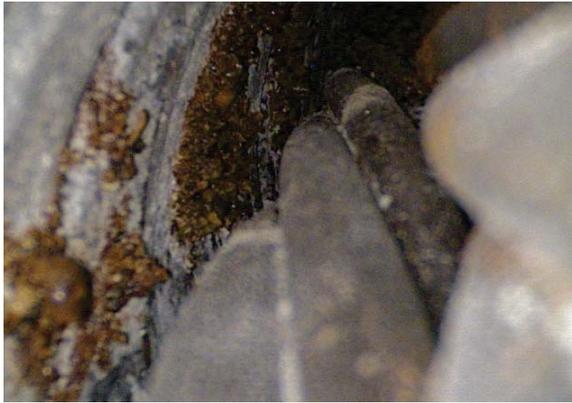
This tendon duct has no grout. Note that there is rust on the duct interior and the steel tendon strands. (Photo courtesy of VSL)

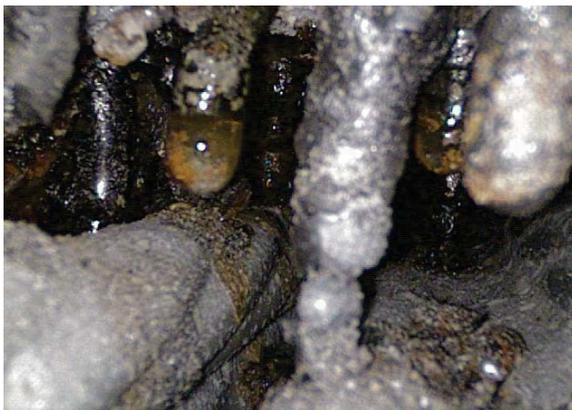
This image shows a duct with exposed tendons in the duct interior. Note the mineral and water deposits. (Photo courtesy of VSL)

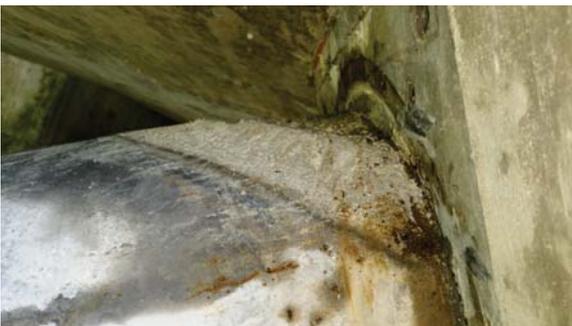
Soft grout can be seen at the anchor of the steel tendon pictured here. (Photo courtesy of VSL)

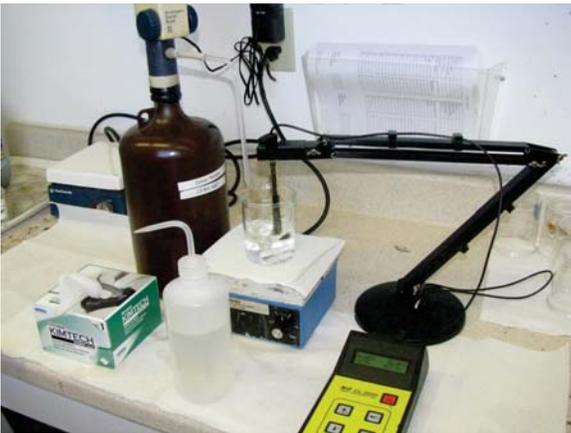
A lab titration process quantifies the chloride content in concrete and grout. (Photo courtesy of SCS)

Chloride Content: Chloride content within the grout also is a concern. The American Association of State Highway and Transportation Officials (AASHTO) allows a maximum chloride concentration of 0.08% with respect to the mass of the grout. The lower the pH of the grout, the lower the chloride concentration required to initiate corrosion of the steel tendons.

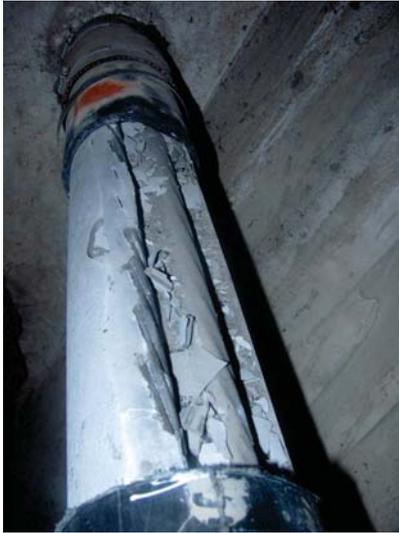
This exterior tendon has a large void. Note that the steel tendon is exposed. (Photo courtesy of SCS)

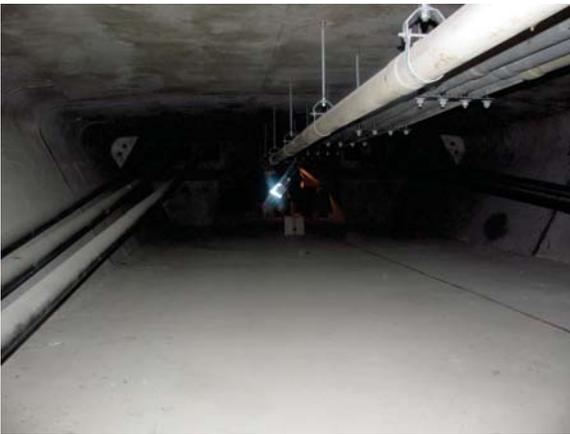
A typical view of external tendons in a post-tensioned structure. (Photo courtesy of SCS)

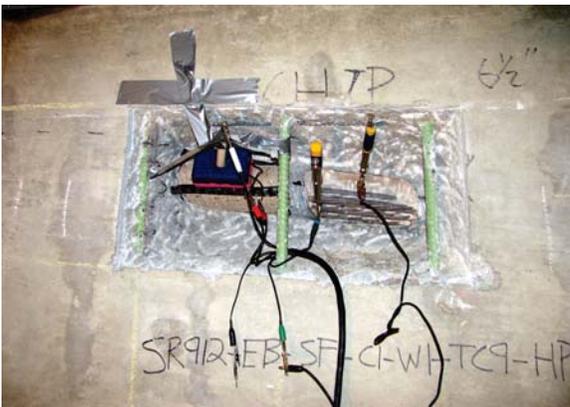
A corrosion rate setup for an interior steel tendon.
(Photo courtesy of SCS)
