Using Critical Thinking to Address Critical Findings on Local Agency Bridges

2019 Ohio Transportation Engineering Conference

BURGESS & NIPLE
Engineers ■ Architects ■ Planners

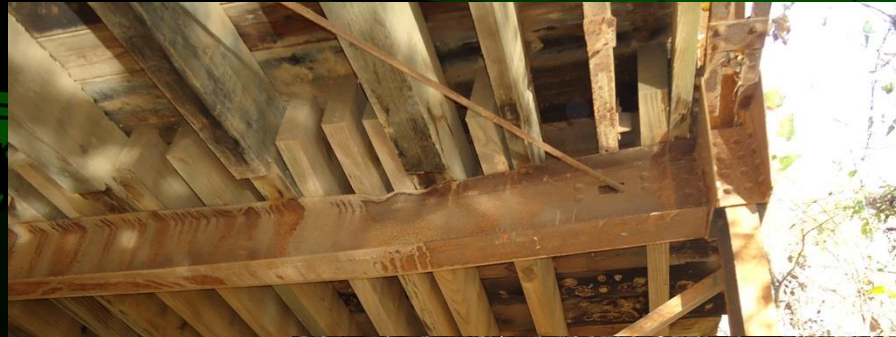
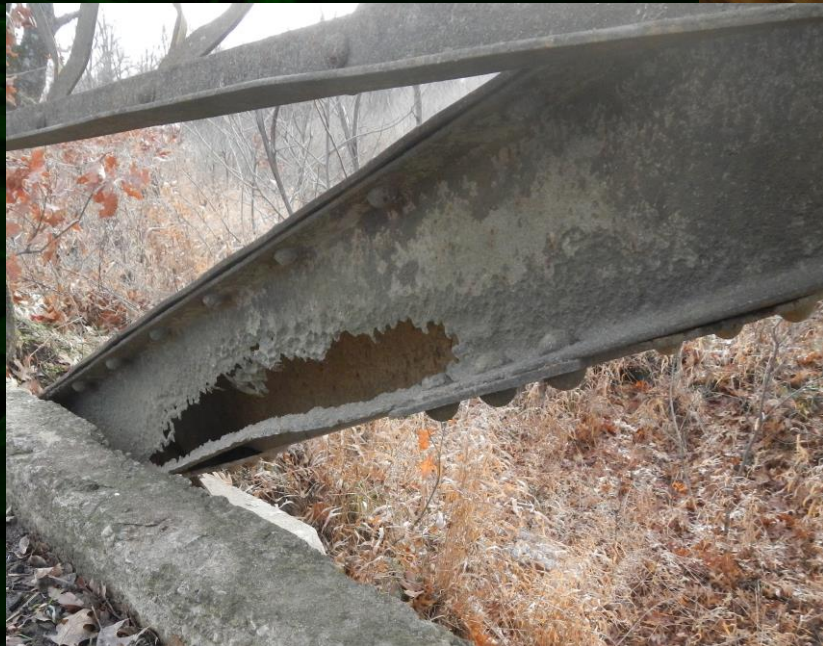
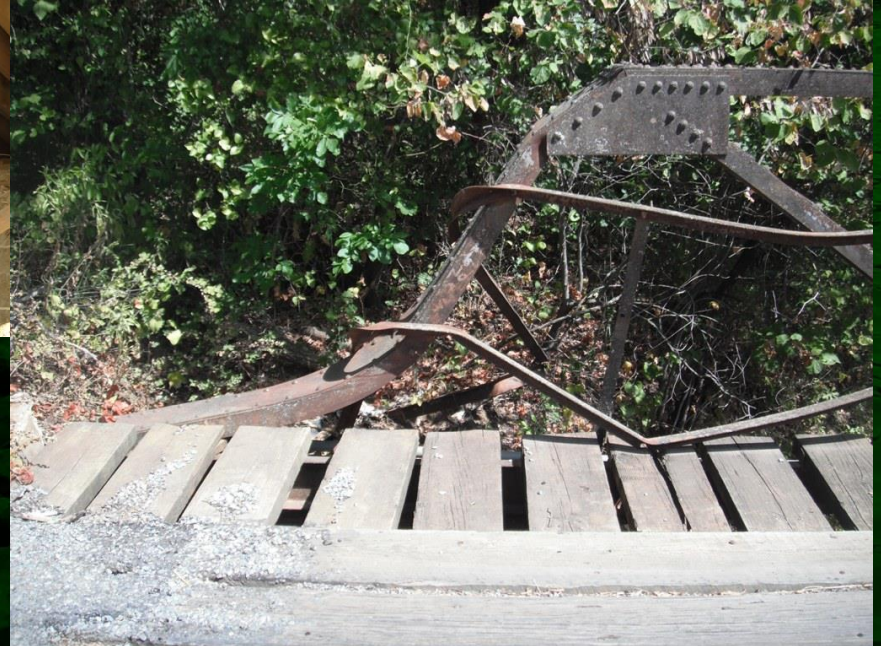
“Structural or safety related deficiency that may pose an immediate threat to the safety of the traveling public”

- **Damage or Loss**

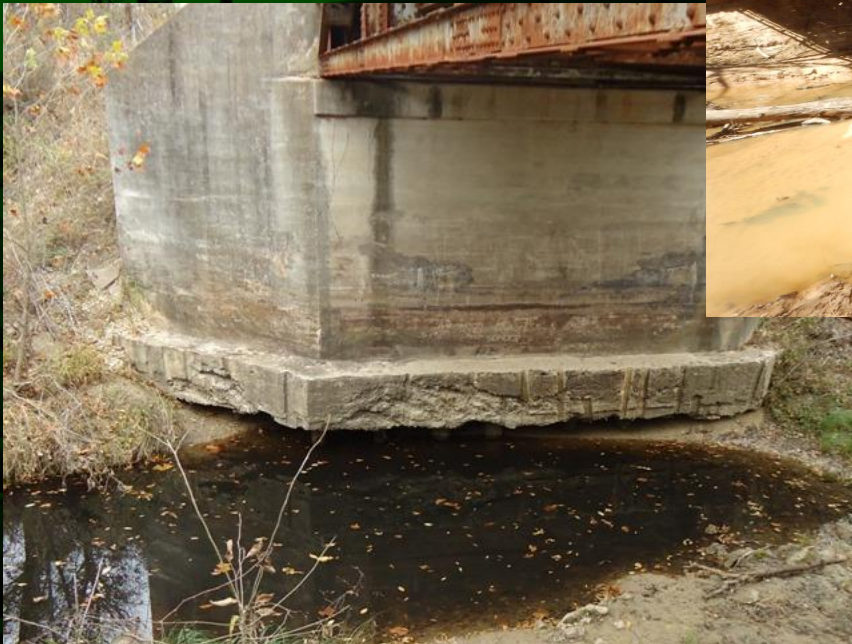
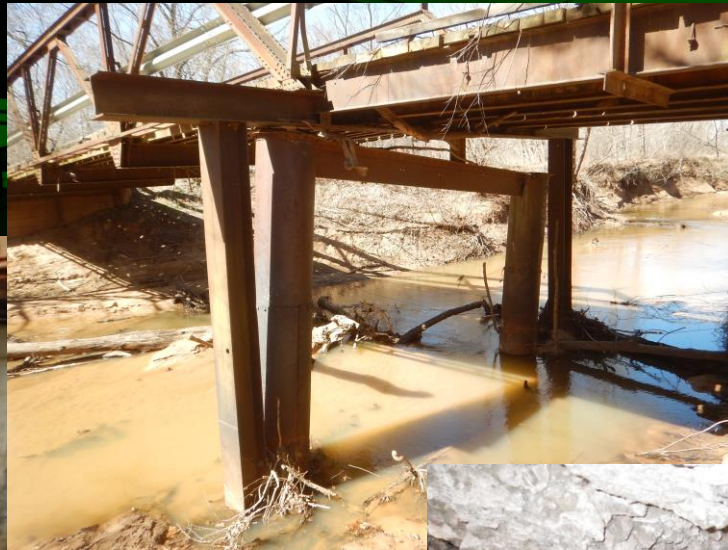
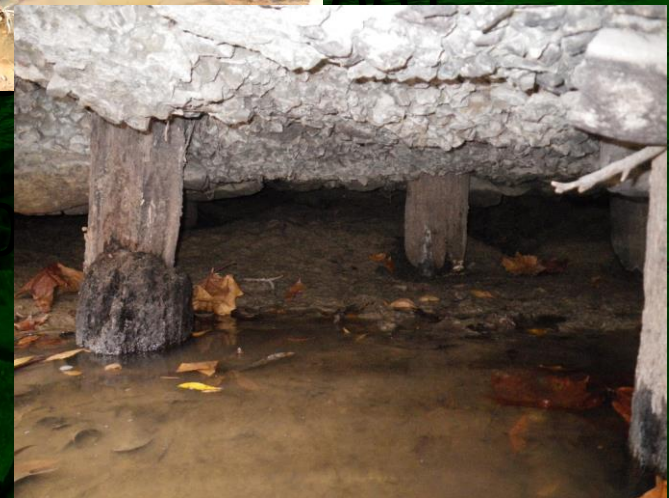
- Damage or Loss
- Scour

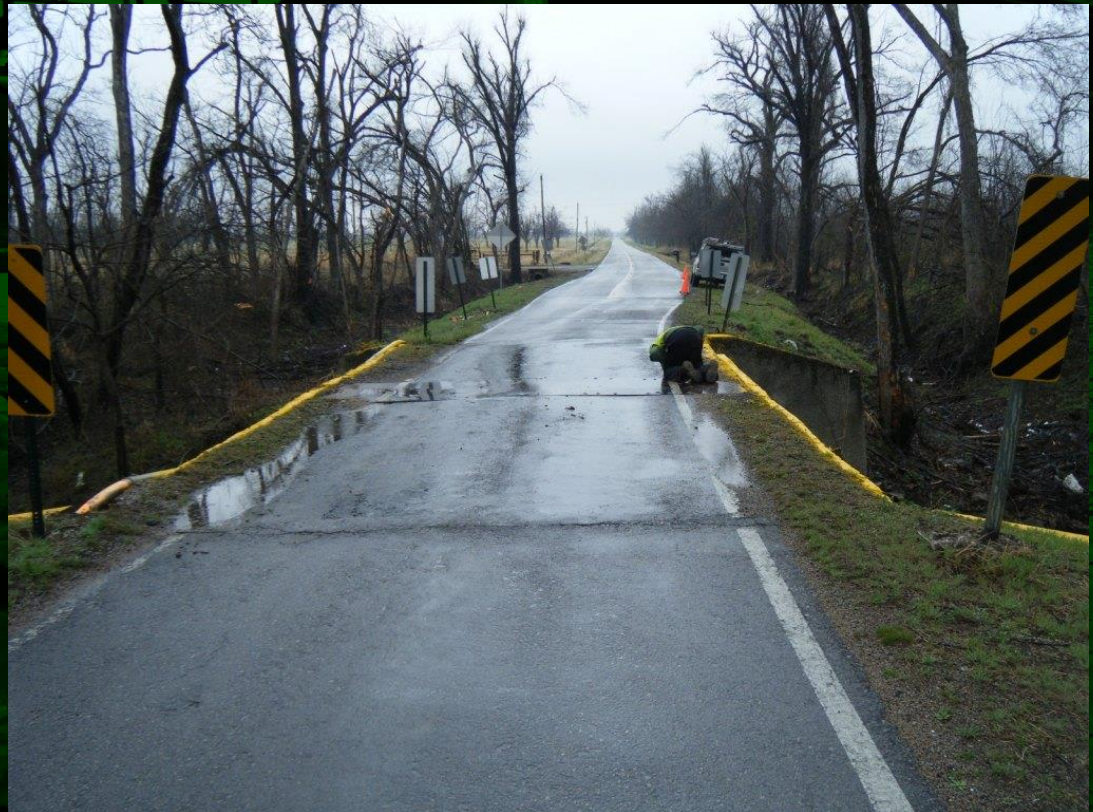
- **Damage or Loss**
- **Scour**
- **Hazard to Public**

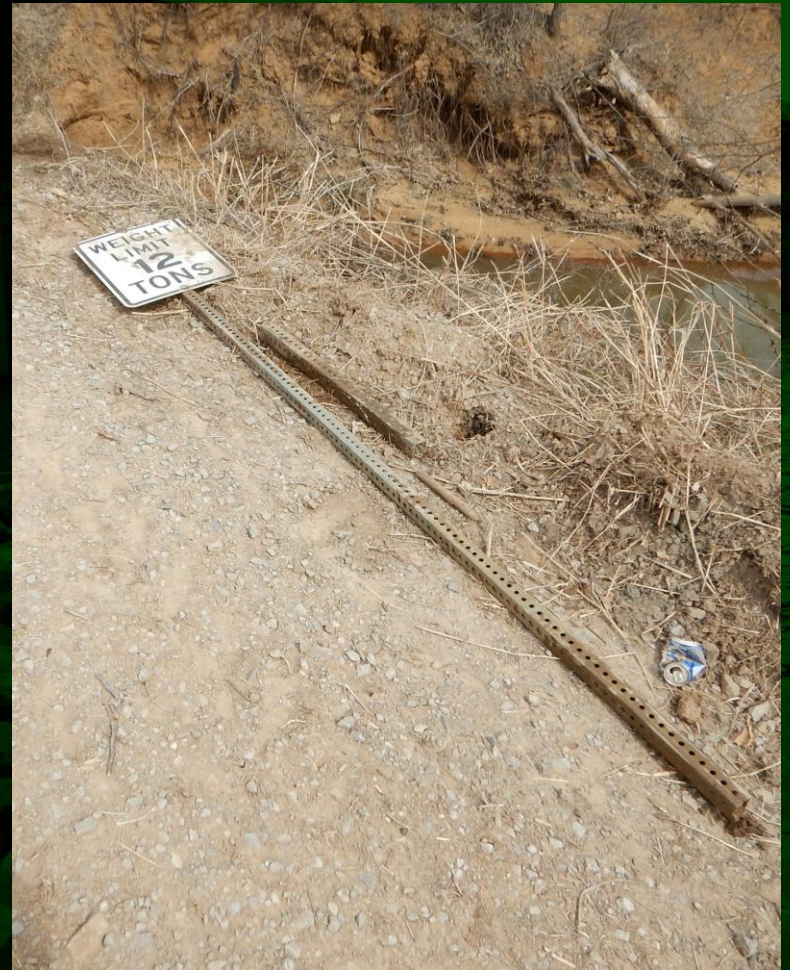
- **Damage or Loss**
- **Scour**
- **Hazard to Public**
- **Missing or Incorrect Signs**

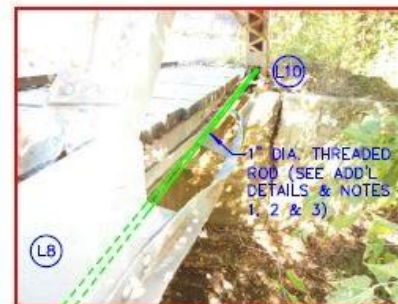
OVERALL REPAIR

1. THREADED ROD SHALL BE 1" DIAMETER & HAVE MINIMUM 127.7ksi YIELD STRENGTH & 150ksi ULTIMATE STRENGTH AND SHALL CONFORM TO ASTM A722-07 & AASHTO M275 REQUIREMENTS.
2. THE THREADED ROD SHALL BE INSTALLED WITH HARDENED WASHERS AND TWO HEX NUTS AT EACH END & SHALL MEET THE ROD MANUFACTURER'S REQUIREMENTS.
3. THE THREADED ROD NUTS SHALL BE INSTALLED SNUG TIGHT.
4. ALL STRUCTURAL STEEL (CHANNELS, ANGLES & PLATES) SHALL BE 36ksi YIELD STRENGTH MINIMUM (ASTM A709) OR BETTER.
5. ALL WELDING SHALL BE PERFORMED IN ACCORDANCE WITH AWS D1.5 - BRIDGE WELDING CODE. ABRASIVELY CLEAN ALL WELDING SURFACES PRIOR TO WELDING.
6. FIELD VERIFY ALL DIMENSIONS PRIOR TO FABRICATION TO ASSURE PROPER FIT-UP.
7. AFTER INSTALLATION IS COMPLETE, PAINT ALL NEW AND AFFECTED EXISTING STEEL SURFACES WITH TWO COATS OF ZINC-BASED PAINT.

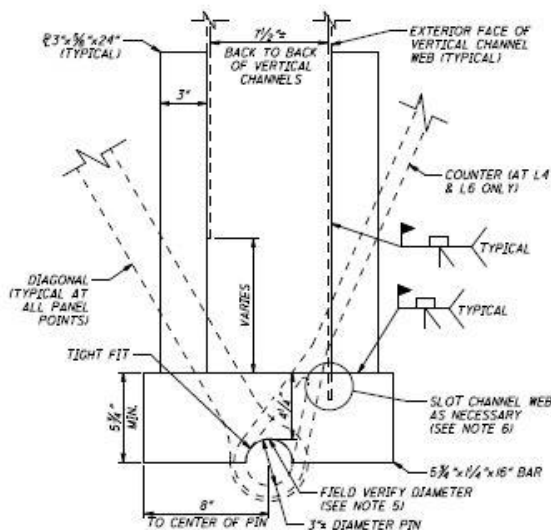
TYPICAL SECTION

PIN NUT, LOWER CHORD, PIN PLATES AND CHANNEL FLANGES NOT SHOWN

- CONTRACTOR SHALL FIELD VERIFY ALL DIMENSIONS PRIOR TO FABRICATION OF STEEL MEMBERS.
- STEEL MEMBERS SHALL BE ASTM A572 (F_y = 50 ksi) AND COATED WITH A ZINC BASED PRIMER. CLEAN EXISTING STEEL SURFACES IN PREPARATION FOR WELDING WITH NEW STEEL MEMBERS.

- STEEL MEMBERS SHALL BE ADDED AT L2-L8 PANEL POINTS ON BOTH TRUSSES (14 LOCATIONS TOTAL, SEE ELEVATION).
- AT L4 AND L6 LOCATIONS, THE ASSEMBLY WILL BE OFFSET FROM THE CENTER OF THE VERTICAL DUE TO THE PRESENCE OF A COUNTER MEMBER. FIT THE ASSEMBLY BETWEEN THE COUNTER AND THE PIN PLATE AS SHOWN.

- EXIST. TRUSS PINS MAY HAVE A STEEL COLLAR AT SOME LOCATIONS. CONTRACTOR MAY REMOVE THE COLLARS BY NON-DESTRUCTIVE METHODS, MAKING SURE TO NOT DAMAGE THE PIN OR THE SURROUNDING MAIN MEMBERS. IF THE COLLAR CANNOT BE REMOVED, FABRICATE THE 5/8x1/4x16" BAR TO FIT AROUND THE COLLAR. BARS SHALL BE FABRICATED TO FORM A BEARING TIGHT FIT AROUND THE COLLAR OR PIN.

- SLOT THE VERTICAL CHANNEL WEB AS NECESSARY TO PLACE THE 5/8x1/4x16" BAR IN THE POSITION SHOWN, MAKING SURE TO NOT DAMAGE THE PIN OR THE SURROUNDING MAIN MEMBERS.

- REOPEN BRIDGE ONLY AFTER 3 TON LOAD POSTING SIGNS HAVE BEEN INSTALLED AT BOTH APPROACHES AND ALL REPAIR WORK IS COMPLETE IN ALL 3 SPANS.

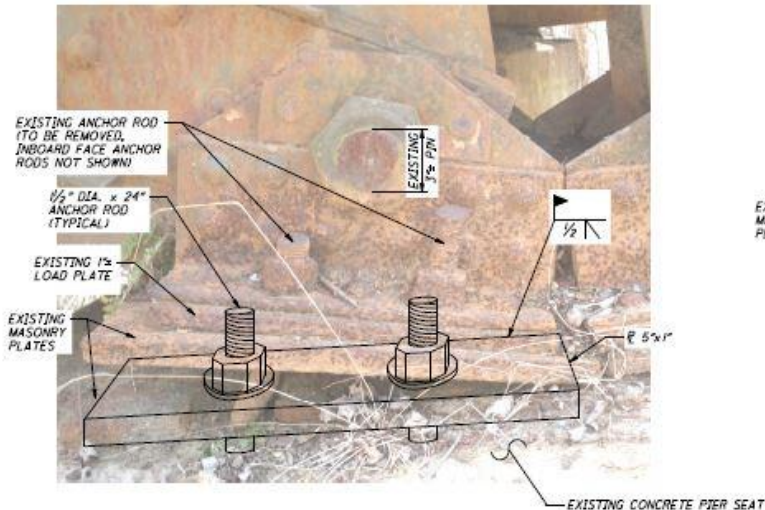
LAYOUT

(PROPOSED PLATE SHOWN IN APPROXIMATE FINAL RE-POSITIONED TRUSS LOCATION)

1. CONTRACTOR SHALL FIELD VERIFY ALL DIMENSIONS PRIOR TO THE FABRICATION OF STEEL MEMBERS. PLATES AND ANCHOR BOLTS SHALL BE ADDED TO THE OUTBOARD FACE OF THE PIER BEARINGS OF THE EAST APPROACH TRUSS ONLY.
2. STEEL PLATE SHALL BE ASTM A572 (FY = 50 ksi) AND COATED WITH A ZINC BASED PRIMER. CLEAN EXISTING STEEL SURFACES IN PREPARATION FOR WELDING WITH NEW STEEL PLATE. ANCHOR RODS SHALL BE FURNISHED ACCORDING TO ASTM A307.
3. REMOVE/CUT ALL EXISTING ANCHOR RODS (INBOARD AND OUTBOARD) ABOVE THE PIER SEAT PRIOR TO POSITIONING THE TRUSS INTO ITS FINAL LOCATION.
4. USE THE NEW STEEL PLATE AS A TEMPLATE FOR DRILLING NEW ANCHOR ROD HOLES INTO THE EXISTING PIER. 2" DIA. HOLES SHALL BE 18" MINIMUM DEPTH AND FILLED WITH CEMENT GROUT.
5. PLACE WASHERS AND HAND-TIGHTEN NUTS ONTO ANCHOR RODS.

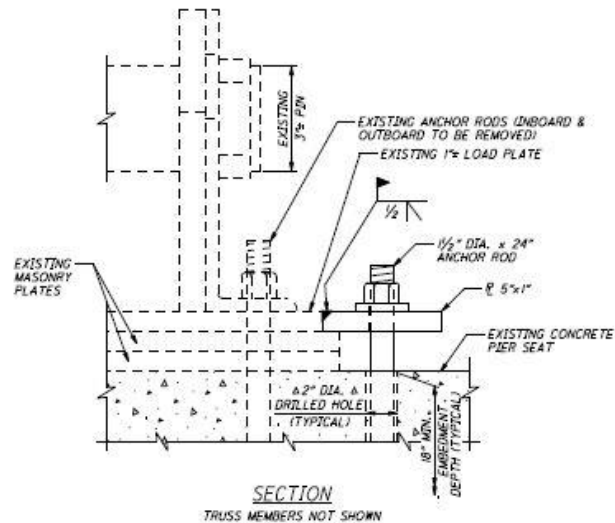
SECTION

TRUSS MEMBERS NOT SHOWN

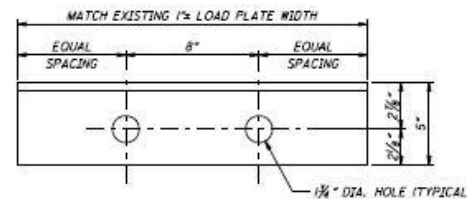
PLATE DETAIL

1" THICK
(2 PLATES TOTAL)
