TECHNICAL PAPER

**Post-Tensioned System &
Cable Stay Bridges:
Diagnosing & Remediating
Corrosive Conditions**

April 2019

BURGESS & NIPLE
Engineers ■ Architects ■ Planners

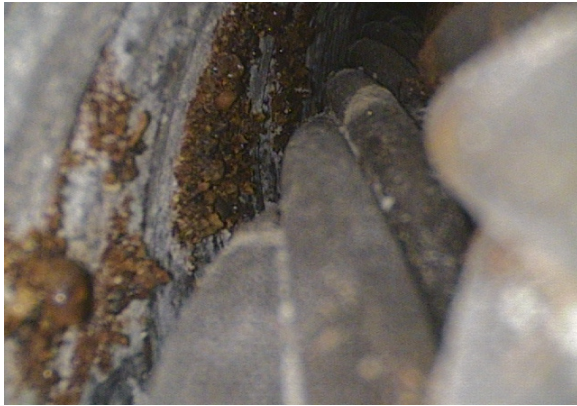
This tendon duct has no grout. Note that there is rust on the duct interior and the steel tendon strands. (Photo courtesy of VSL)

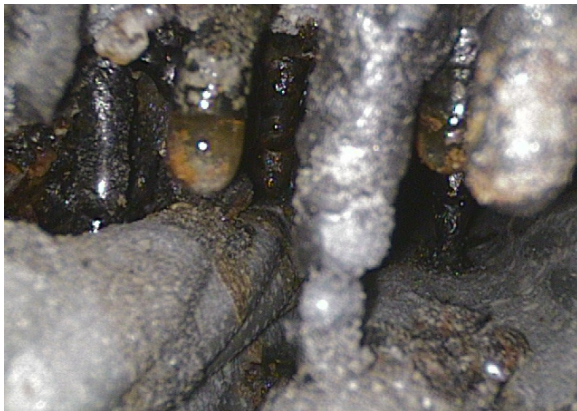
This image shows a duct with exposed tendons in the duct interior. Note the mineral and water deposits. (Photo courtesy of VSL)

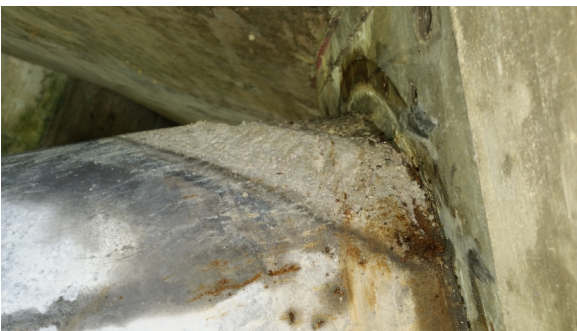
Soft grout can be seen at the anchor of the steel tendon pictured here. (Photo courtesy of VSL)

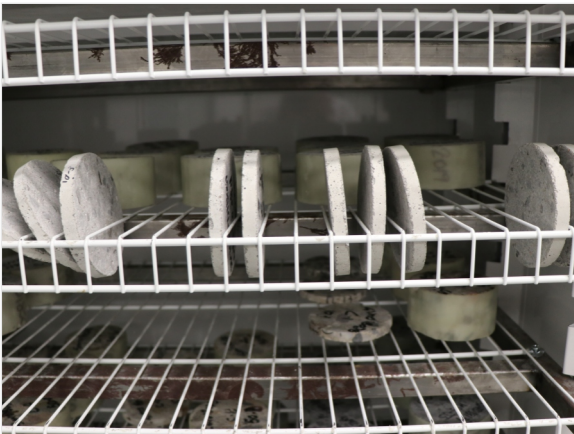
These concrete samples were cut into slices to reflect different depths from the concrete surface. They are ready to be tested for chloride-ion and moisture content. (Photo courtesy of VSL)

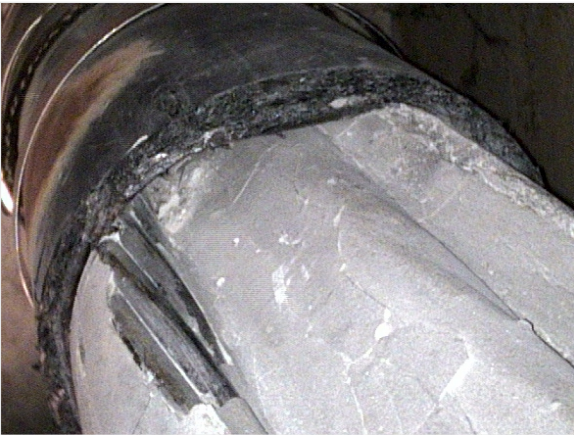
External PTS duct: Note that the steel tendon is partially exposed and has voids indicating an incomplete grouting procedure.

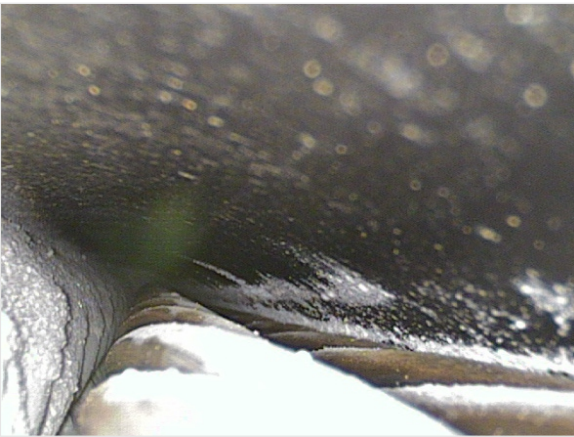
External PTS duct: An incomplete grouting procedure has resulted in voids and corrosion of the exposed strands.

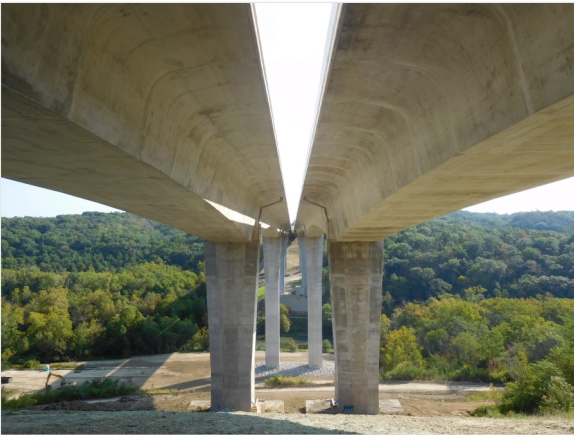
The twin Jeremiah Morrow bridges carry I-71 over the Little Miami River in Warren County, OH. Internal and external PTS, CIP segmental box construction.

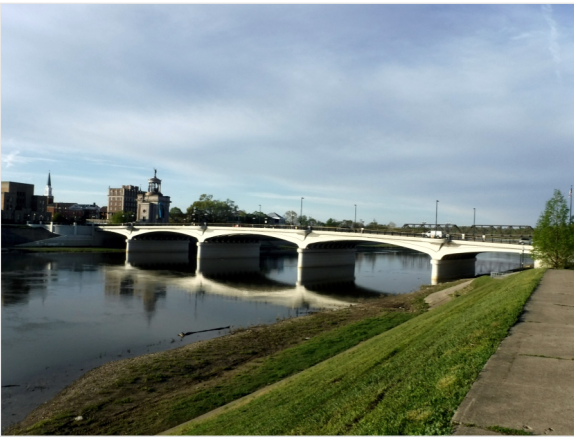
The State Route 129 bridge over the Great Miami River in Butler County, OH includes internal PTS, precast haunched girders.

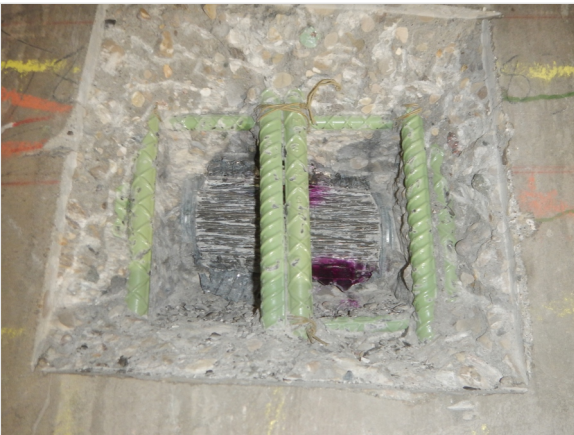
This exposed internal steel tendon has a 1" void at the top of the duct. The purple colored areas have been sprayed to confirm that the pH of the grout is 12 to 13.

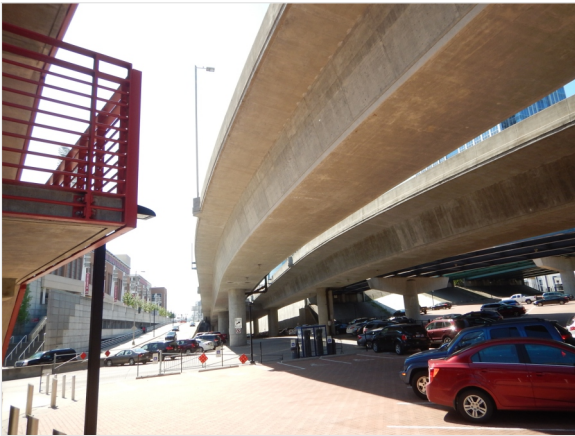
This ramp from Second Street to EB US50 over Broadway in Cincinnati, OH, is a five-span structure with internal PTS in the webs and CIP.

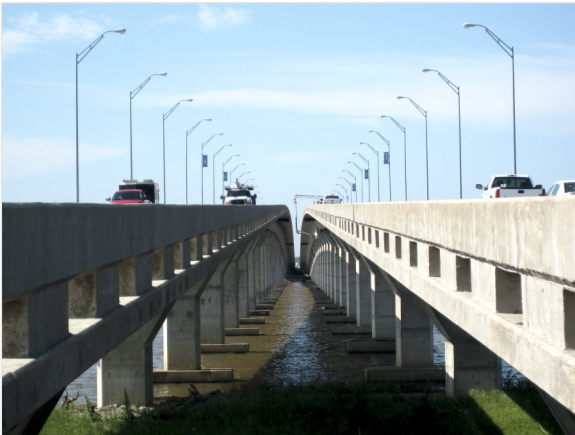
The twin Sailboat Bridges carry US 59 over Grand Lake in Delaware County, Oklahoma. Twenty-five spans comprise each structure and are supported by external PTS.

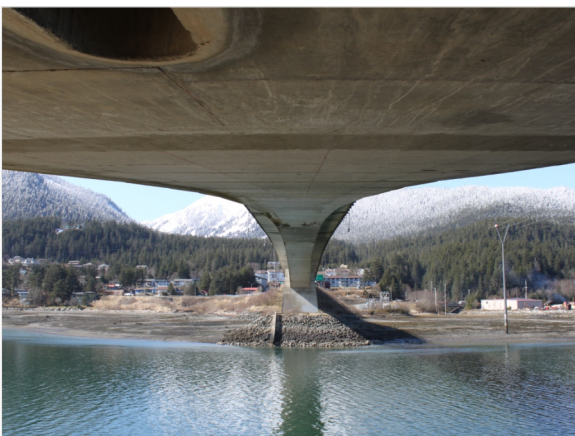
The Juneau Douglas Bridge Road over the Gastineau Channel in Juneau, Alaska, consists of an internal PTS box girder.
