TECHNICAL PAPER

# **Revitalization of an Ohio River Suspension Bridge**

**Market Street Bridge**

This presentation was delivered at the  
**2012 International Bridge Conference**

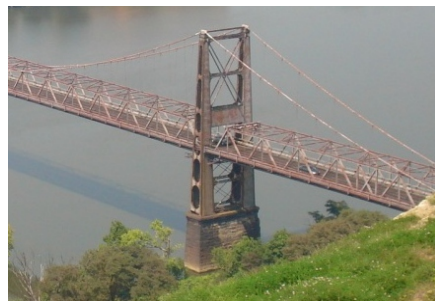
**Figure 2 - Market Street Bridge**

The **Market Street Bridge**, shown in Figure 2, is a cable suspension bridge constructed in 1905 to carry tin mill workers in streetcars from their homes in Ohio to the mill in West Virginia. This southernmost bridge serves local traffic consisting of commuters, light commercial traffic and emergency vehicles.

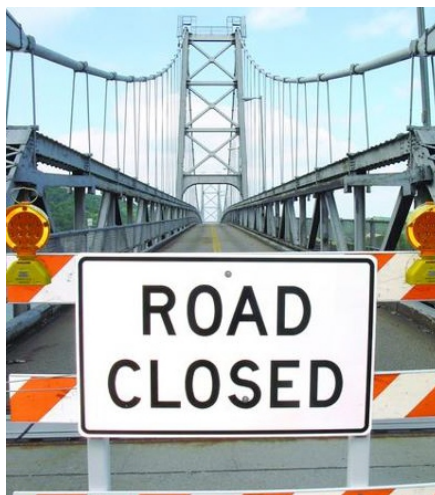
**Figure 3 - Fort Steuben Bridge**

The **Fort Steuben Bridge**, shown in Figure 3, carried 3,000 vehicles per day on Freedom Way and is the northernmost bridge. This cable suspension bridge was constructed in 1928.

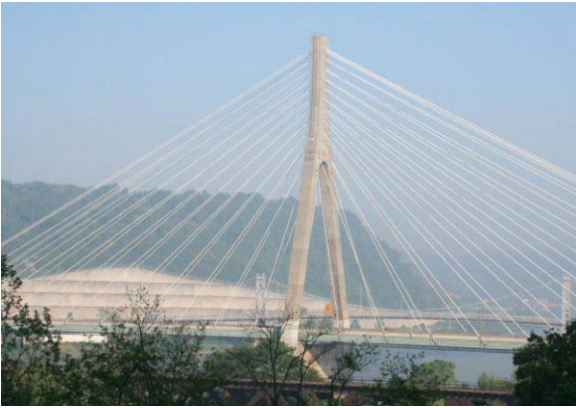
**Figure 4 – Veterans Memorial Bridge**

The **Veterans Memorial Bridge**, shown in Figure 4, carries US Route 22 with a modern cable stay main span. This bridge was constructed in 1990 and serves over 30,400 vehicles per day.

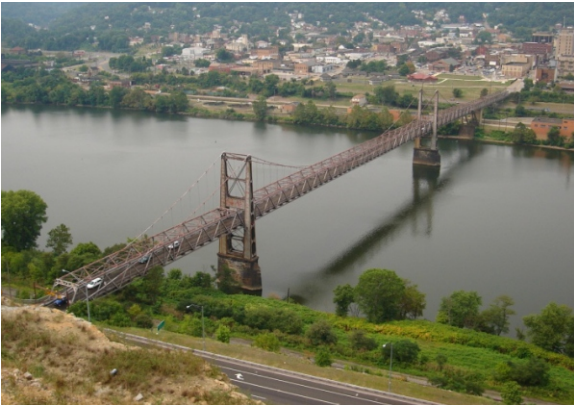
**Figure 5 – Elevation View  
(Before Renovation)**

The overall length of the bridge is 1,794 feet. The three cable suspension spans over the river are stiffened by a welded Warren through truss (see Figure 5). The main span is 700 feet long. The west approach consists of two deck girder spans and five spans of the original riveted steel through truss, which is a quadrangular Warren with verticals. The cables are suspended from two steel towers that rise approximately 210 feet from cut stone piers. The substructure consists of cut stone piers, concrete stub abutments, and both concrete and steel bents. The bridge serves two lanes of traffic on an open steel grid deck. A cantilevered sidewalk provides pedestrian access on the downstream side of the trusses. In addition to the river, the bridge spans over railroad tracks on both sides of the river, two city streets, and four lanes of Ohio Route 7.

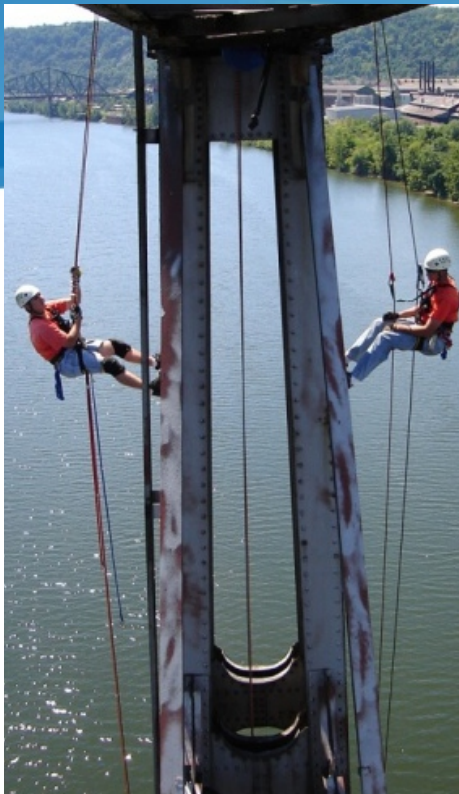
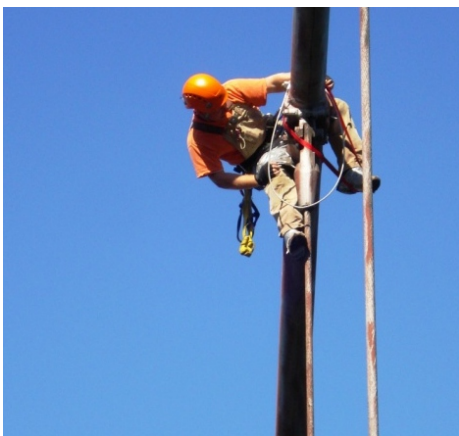
The bridge type and load posting does not permit reasonable use of heavy inspection access equipment such as manlifts and underbridge inspection trucks. B&N uses adapted rock climbing techniques to access the bridge (see Figures 6, 7, & 8). This progressive method allows a hands-on inspection while inspectors are safely supported by ropes or lanyards secured to the bridge components.

Rappelling of the towers and climbing of the cables and trusses allows inspectors access without closing traffic. The suspension spans floor system is equipped with rolling scaffolding.

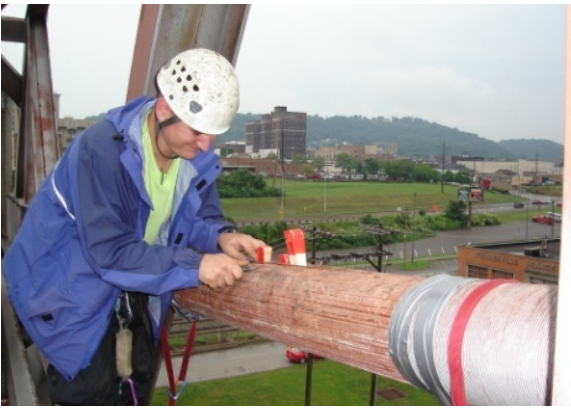
**Figure 9 – Strand Inspection**

In addition to the standard inspection procedures, the cables were unwrapped at several locations and the strands were wedged apart as shown in Figure 9 (next page). The tower saddle caps were also removed to reveal the cable condition in this high stress location. Due to the presence of heavy section loss, detailed notes and measurements of each floor system member were documented to determine the remaining capacity.

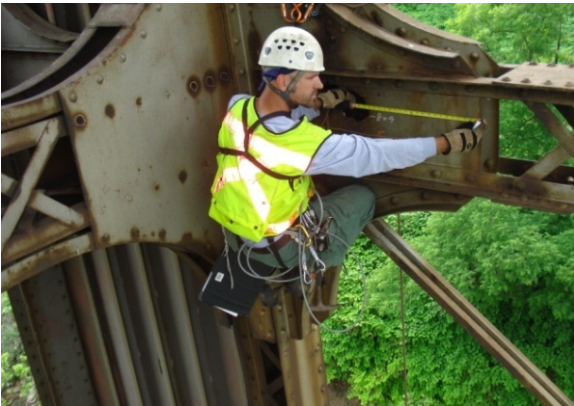
**Figure 10 – Typical Tower Bracing**

In 2009, the overall condition of the bridge was rated as poor. The towers controlled the load rating. The riveted tower columns are laced and braced with curved gusset plates. Previous strengthening repairs added full height plates on the transverse faces of the towers by stitch welding. Pack rust was causing these plates to bow away from the tower columns and breaking the stitch welds. Various bracing gussets had deteriorated with through holing (Figure 10 on next page) and

broken lacing bars. The base of the tower columns had isolated areas of section loss.

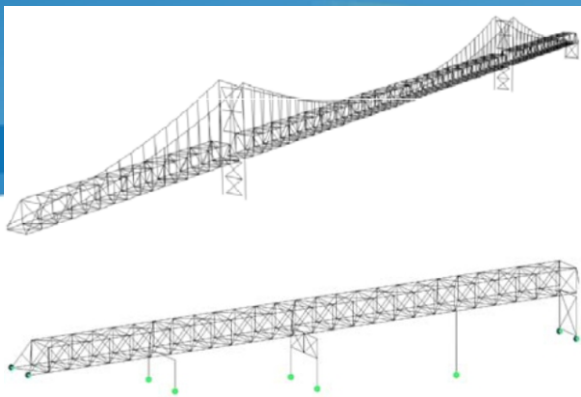
**Figure 11 – Structural Models**

A team of employees from five Burgess & Niple offices was challenged to evaluate the most critical needs and design repairs to rehabilitate the Market Street Bridge in a very aggressive timeframe. The B&N team performed fatigue and structural analyses on the aging structure. A 3-D model of the bridge was developed using the computer program MIDAS, which is an acronym for Modeling, Integrated Design & Analysis Software, (see Figure 11).

A 3-D model of the bridge was developed using MIDAS software, and the B&N team performed fatigue and structural analyses on the aging structure. The gusset plate connections of the approach truss were load rated. The results confirmed the need for repairs. The analyses also revealed that a few members needed immediate attention, repair plans were developed and repairs were performed by WVDOT personnel. B&N accelerated design of structural steel repairs by using inspection photographs in the plans. Instead of providing line work for the existing members, repair notes and details were superimposed onto the photographs.

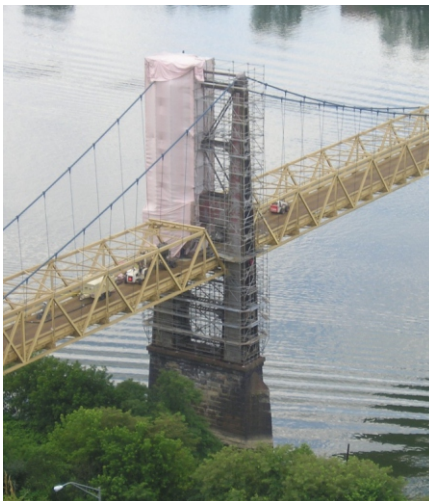
**Figure 17 – Tower Containment**

The cleaning and painting operations cost more than all the other repairs combined. The containment was limited to avoid overloading the bridge members keeping with the 5 ton posting. The towers were completely surrounded by 17 stories of scaffolding and contained (see Figure 17). As the first major bridge structure in West Virginia to receive a penetrant sealer and calcium sulfonate paint system, this project is leading the way to better coating protection.

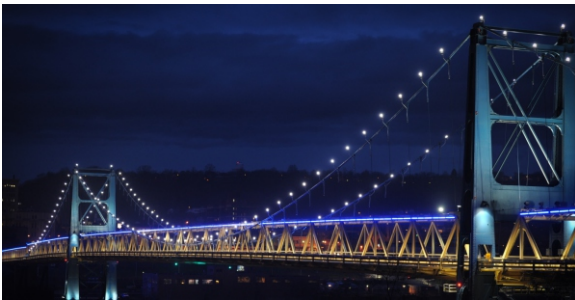
**Figure 18 – Decorative Lighting**

The state-of-the-art decorative lighting makes the project unique. The catenary lighting delineates the cables with 160 white necklace luminaries. The towers are illuminated by 60 directional floodlights, and a blue LED stripe accentuates the upper chords of the truss. The sidewalk railing was also brightened with 212 fixtures. The lighting scheme provides a striking aesthetic appeal in the night sky.
